Debris/Ice/TPS Assessment and Integrated Photographic Analysis of Shuttle Mission STS-68

**DEBRIS/ICE/TPS ASSESSMENT
AND
INTEGRATED PHOTOGRAPHIC ANALYSIS
OF
SHUTTLE MISSION STS-68**

30 September 1994

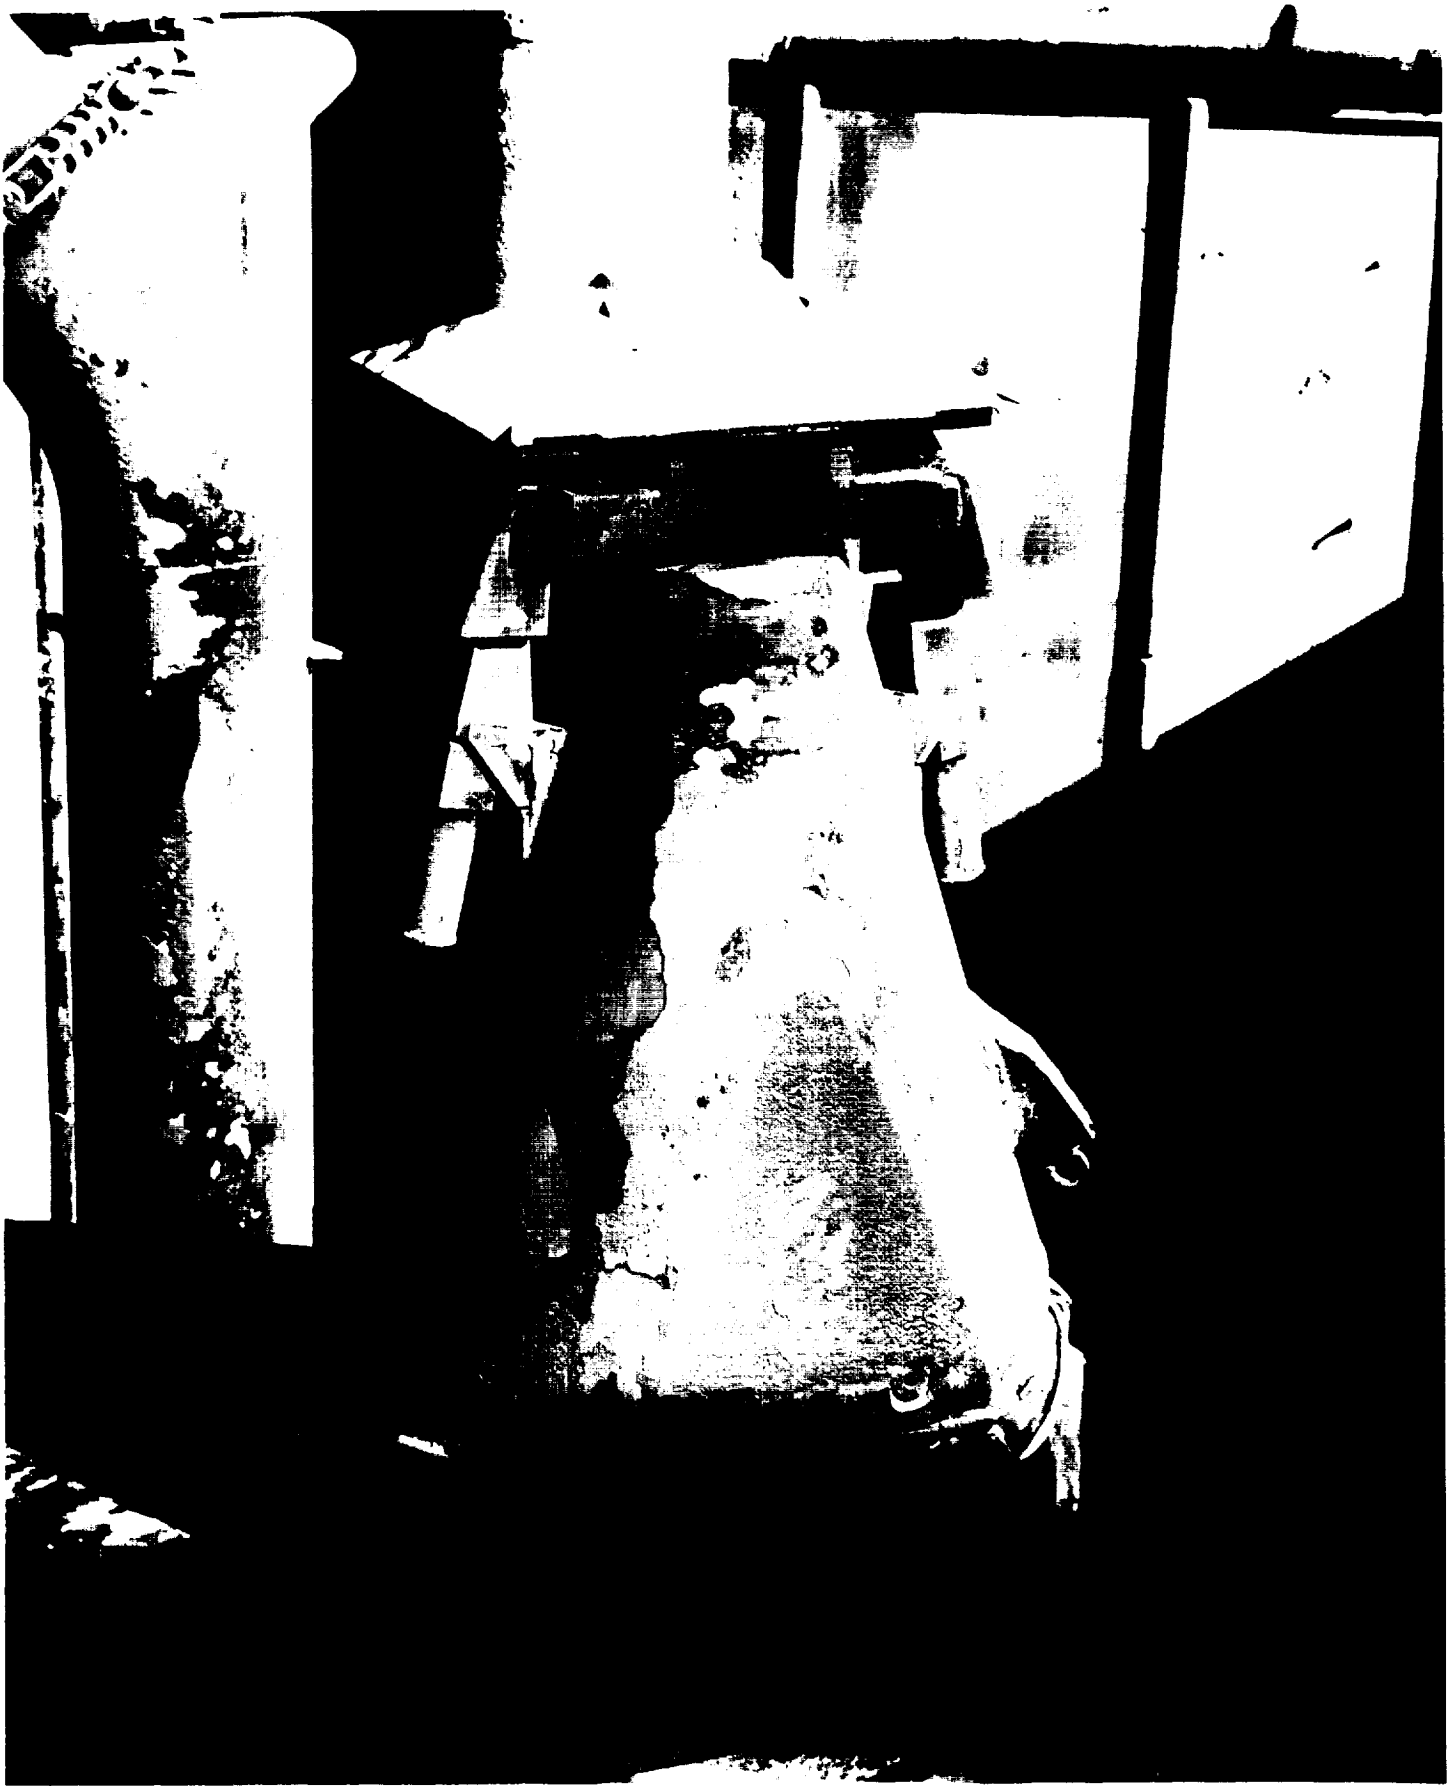
Photo 12 : North Holddown Post Blast Cover Erosion

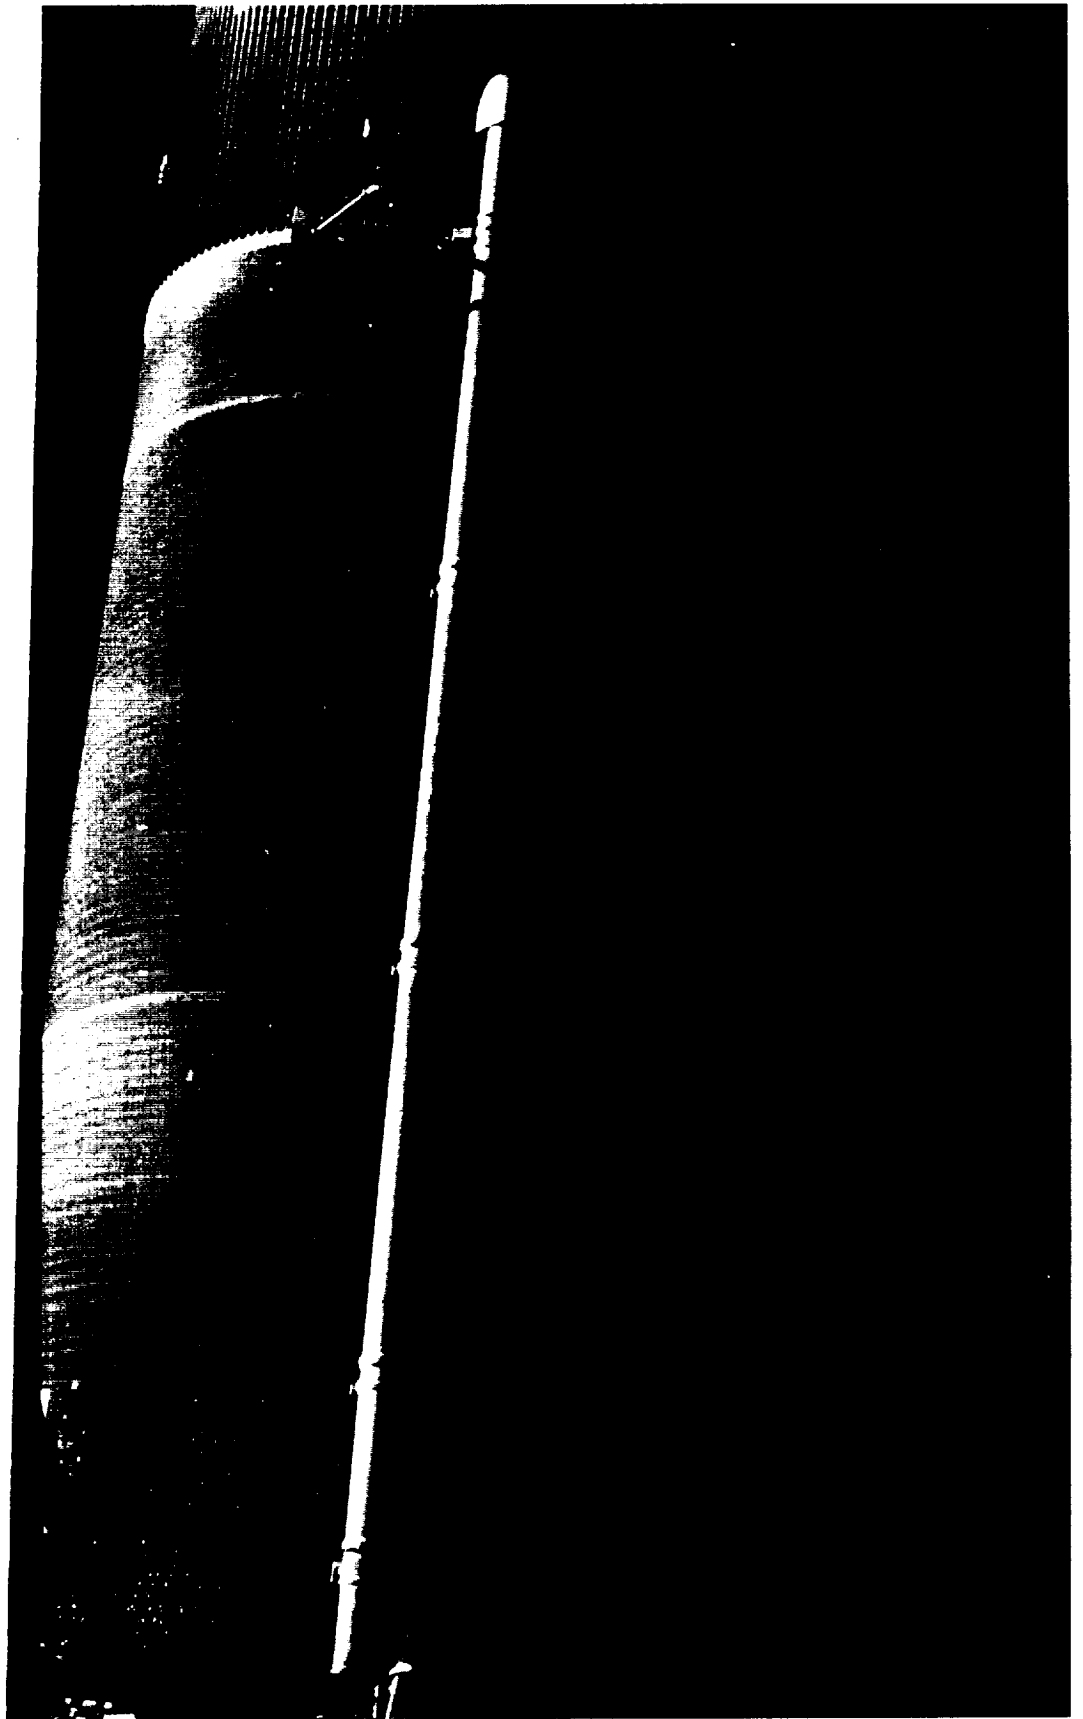
Photo 19 : View of Jack Pad Closeouts and +Z Acreage

Foam, approximately 10 inches in length, was missing from an intertank stringer head at XT-1050 forward of the bipods. The divot exposed the substrate. The bipod jack pad closeouts were intact and appeared to be in excellent condition.

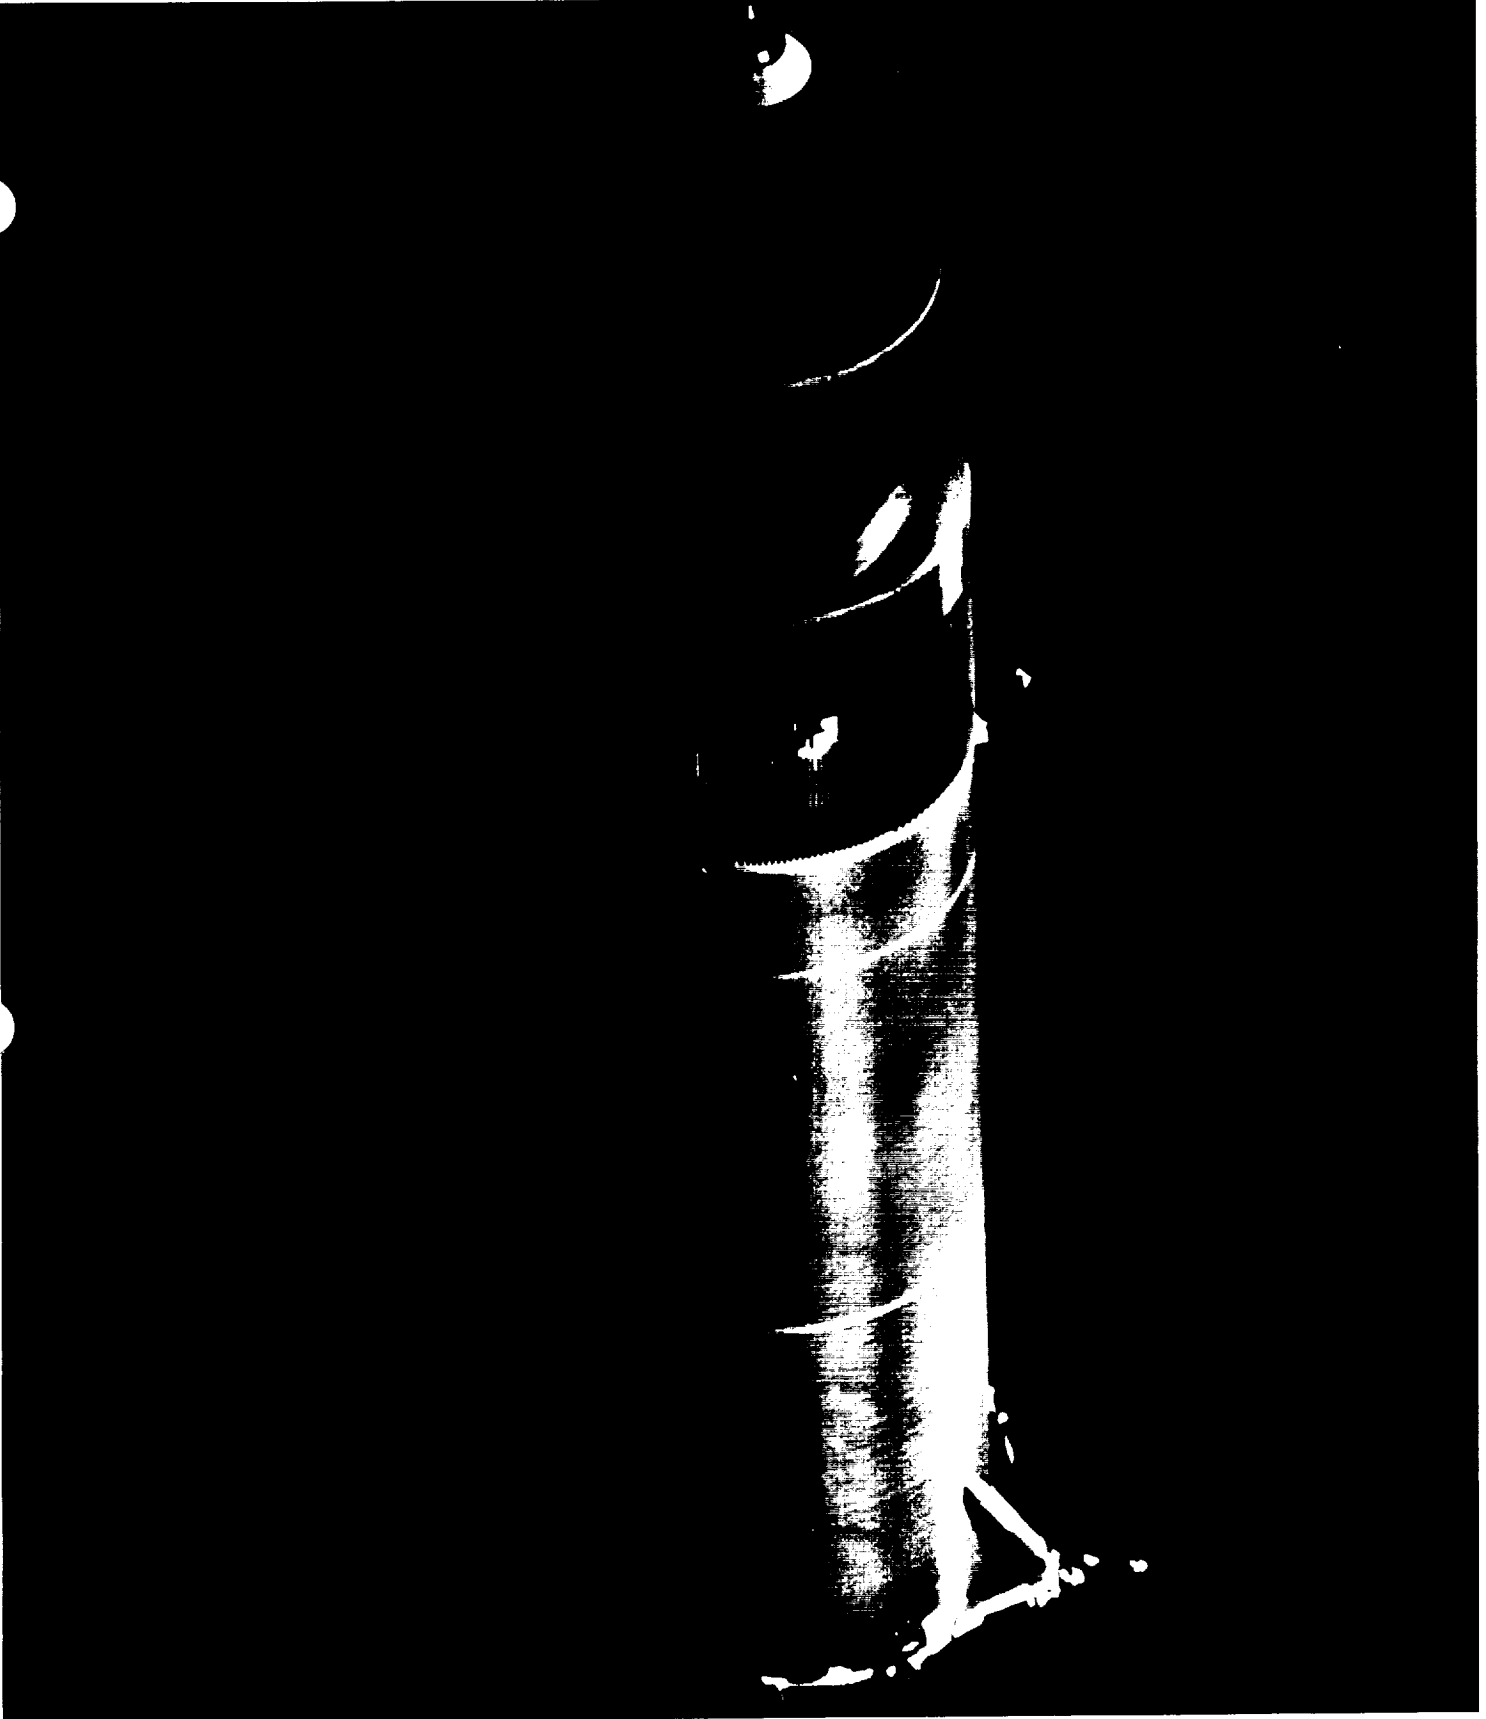
Photo 20 : View of Nosecone and -Y Acreage

No TPS damage was visible on the nosecone. BSM burn scar on the LO2 tank acreage was typical. Note 8-10 inch divot at LH2 tank-to-intertank flange closeout aft of flight umbilical carrier plate area.

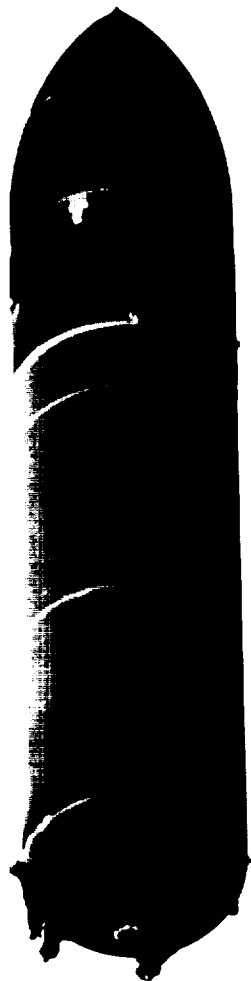
Photo 21 : View of Aft Dome and -Z Acreage

LO2 tank, LH2 tank, and aft dome TPS acreage were in good condition with no apparent anomalies. Charring of aft dome and erosion of manhole cover TPS closeouts was typical. Note two divots in intertank stringer head TPS at the LH2 tank-to-intertank flange closeout area.

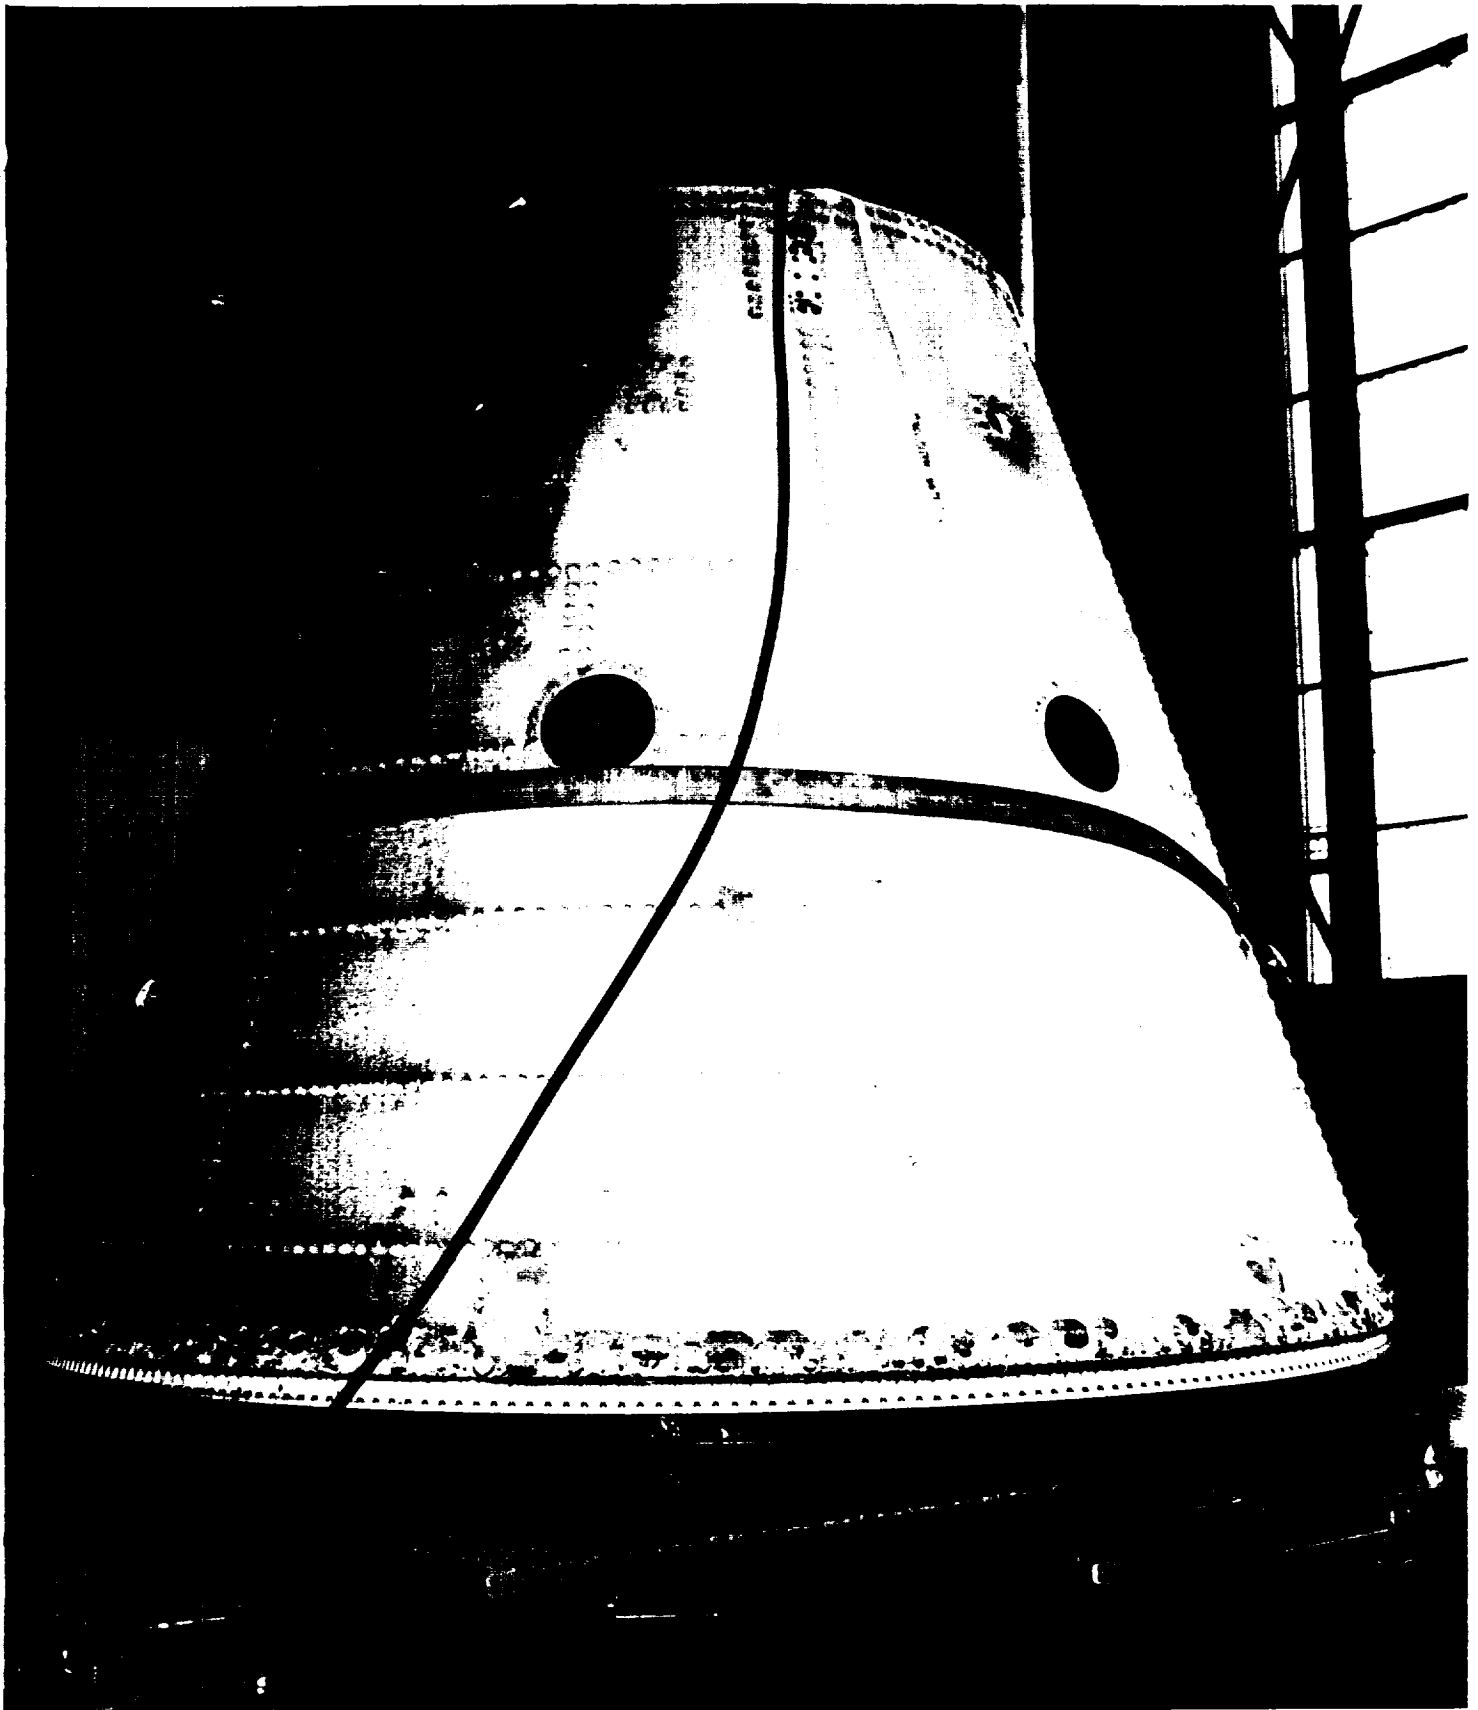
Photo 25 : RH Frustum

The RH frustum was missing no TPS but had 26 MSA-2 debonds over fasteners
The BSM aero heat shield covers had locked in the fully opened position.

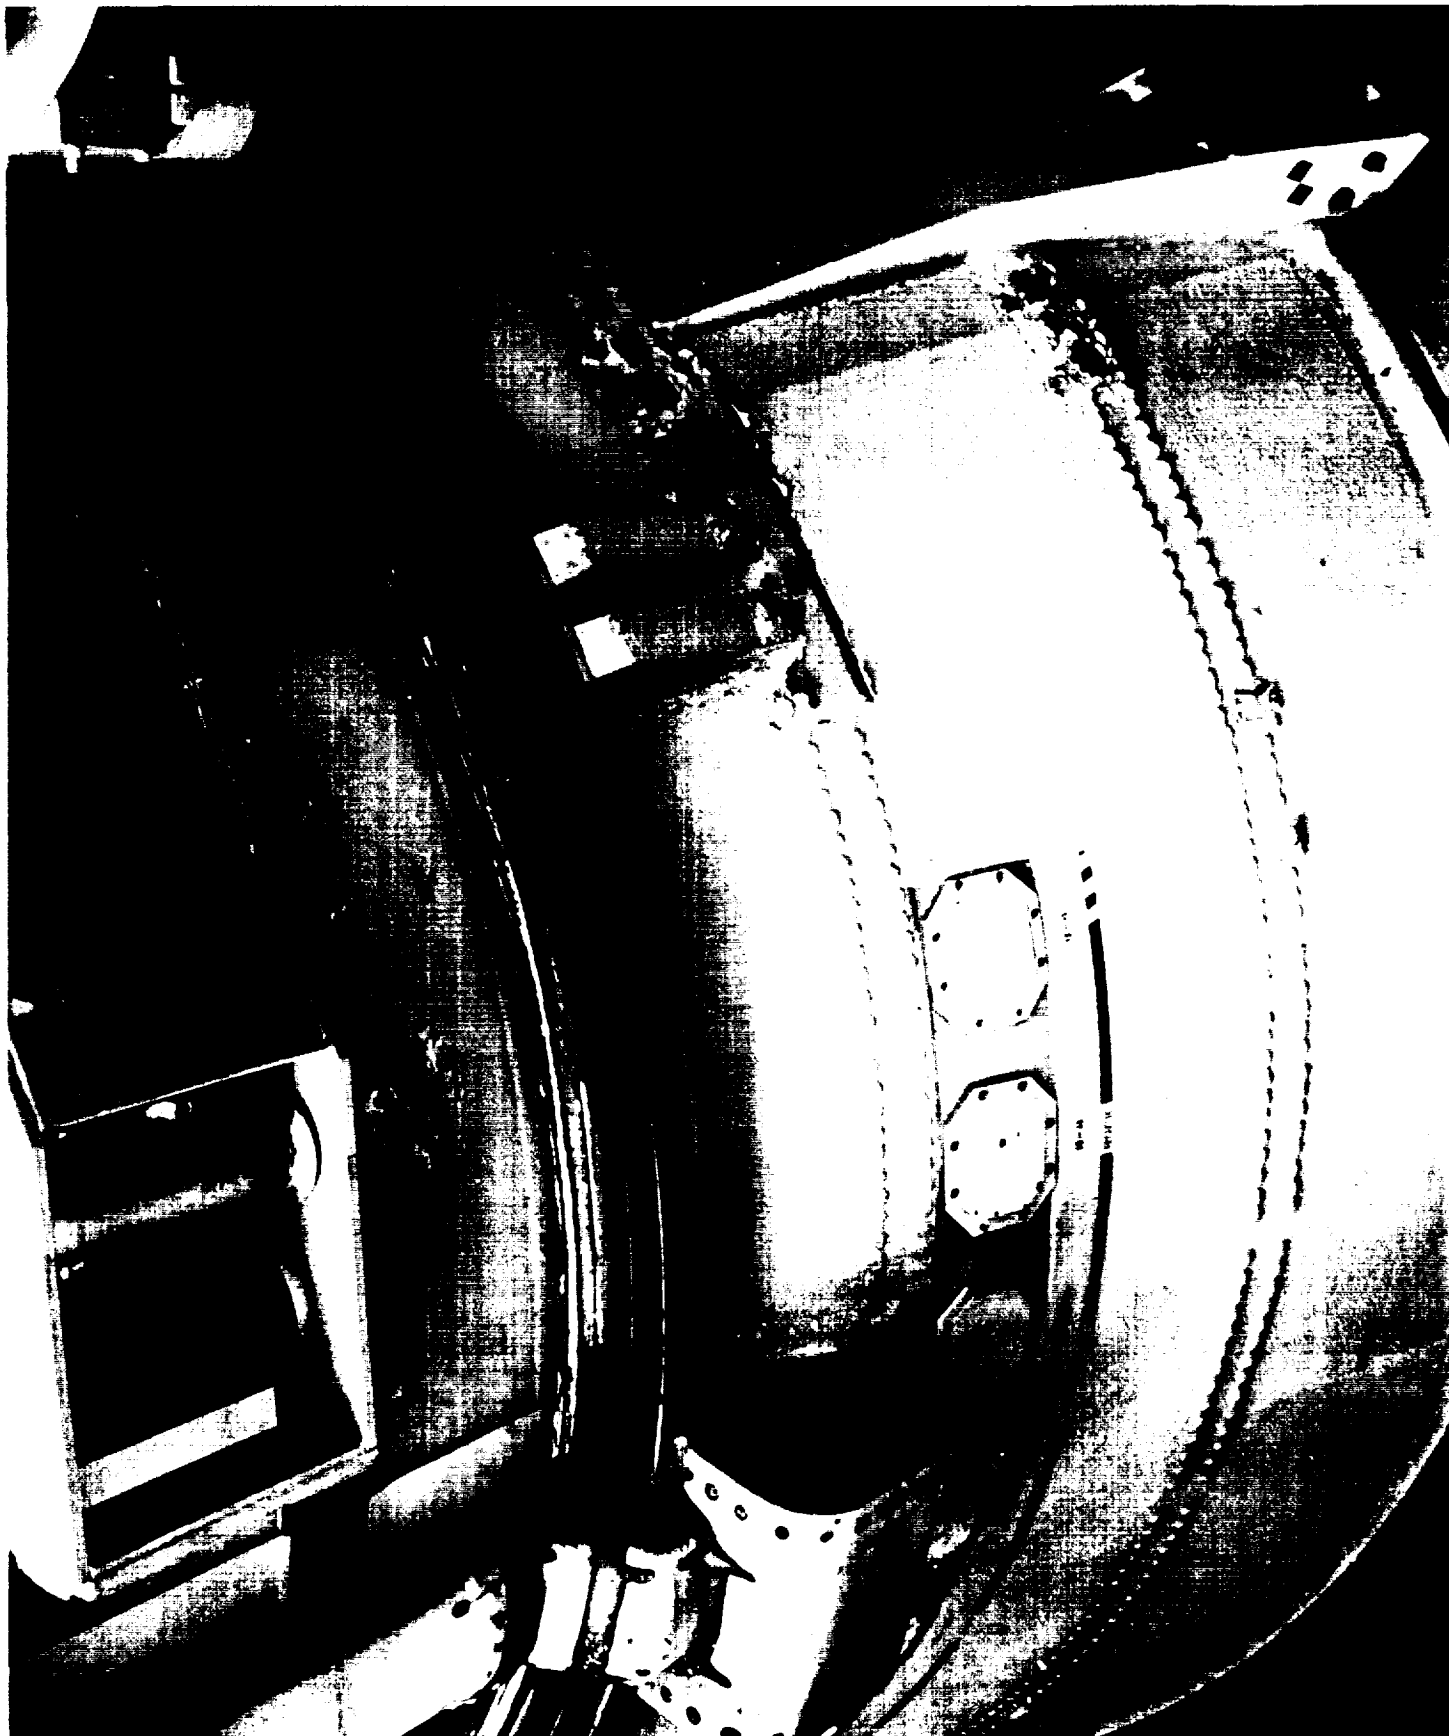
Photo 27 : RH Aft Skirt

Aft skirt acreage TPS was generally in good condition.
Hypalon paint was blistered/missing where the BTA closeouts had been applied.

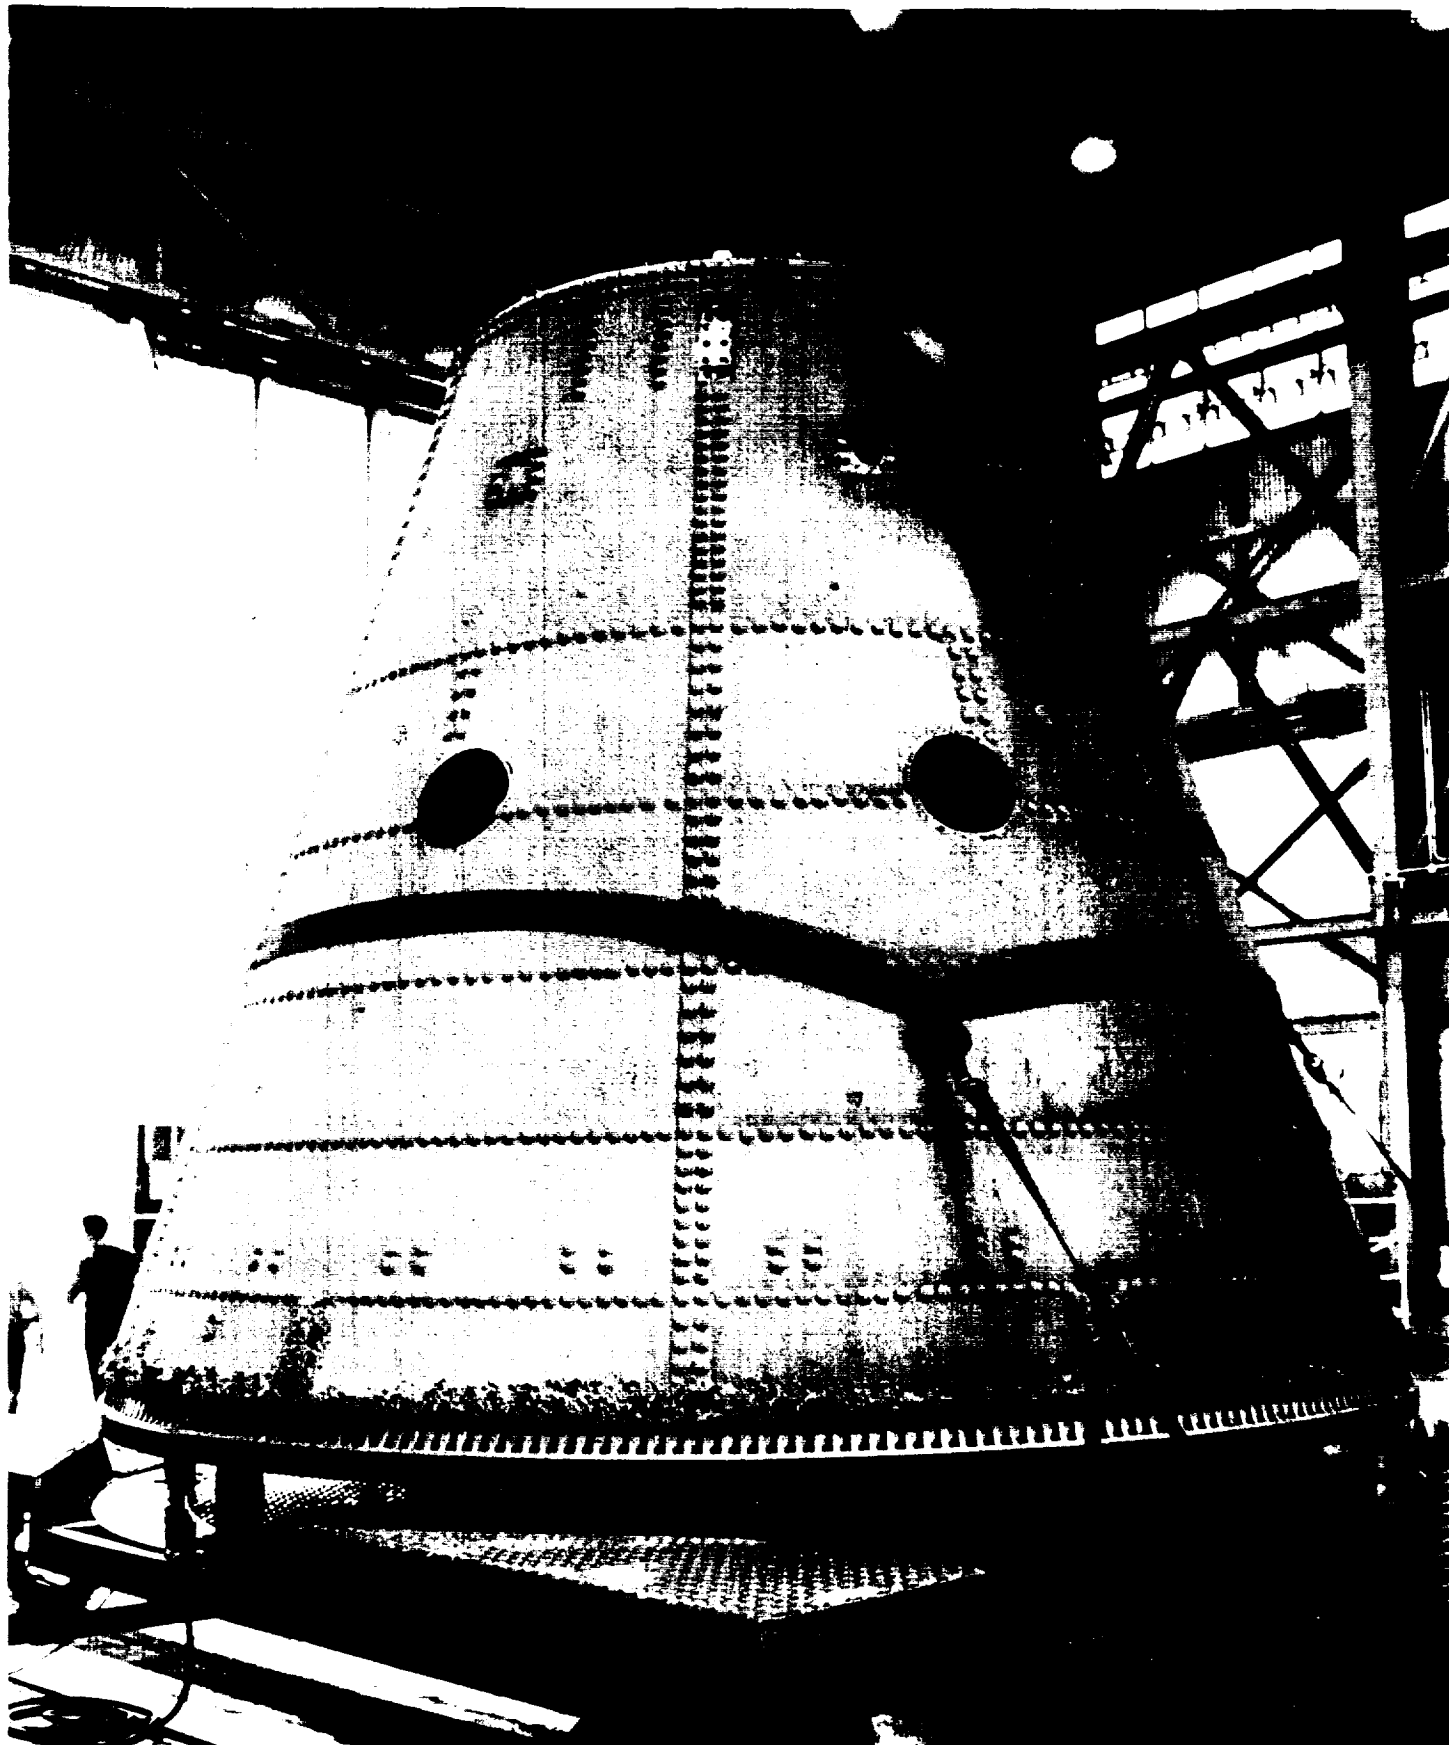
Photo 28 : LH Frustum

The LH frustum was missing no TPS but had 15 MSA-2 debonds over fasteners. Hypalon paint was blistered/missing where the BTA closeouts had been applied. All BSM aero heat shield covers had locked in the fully opened position.

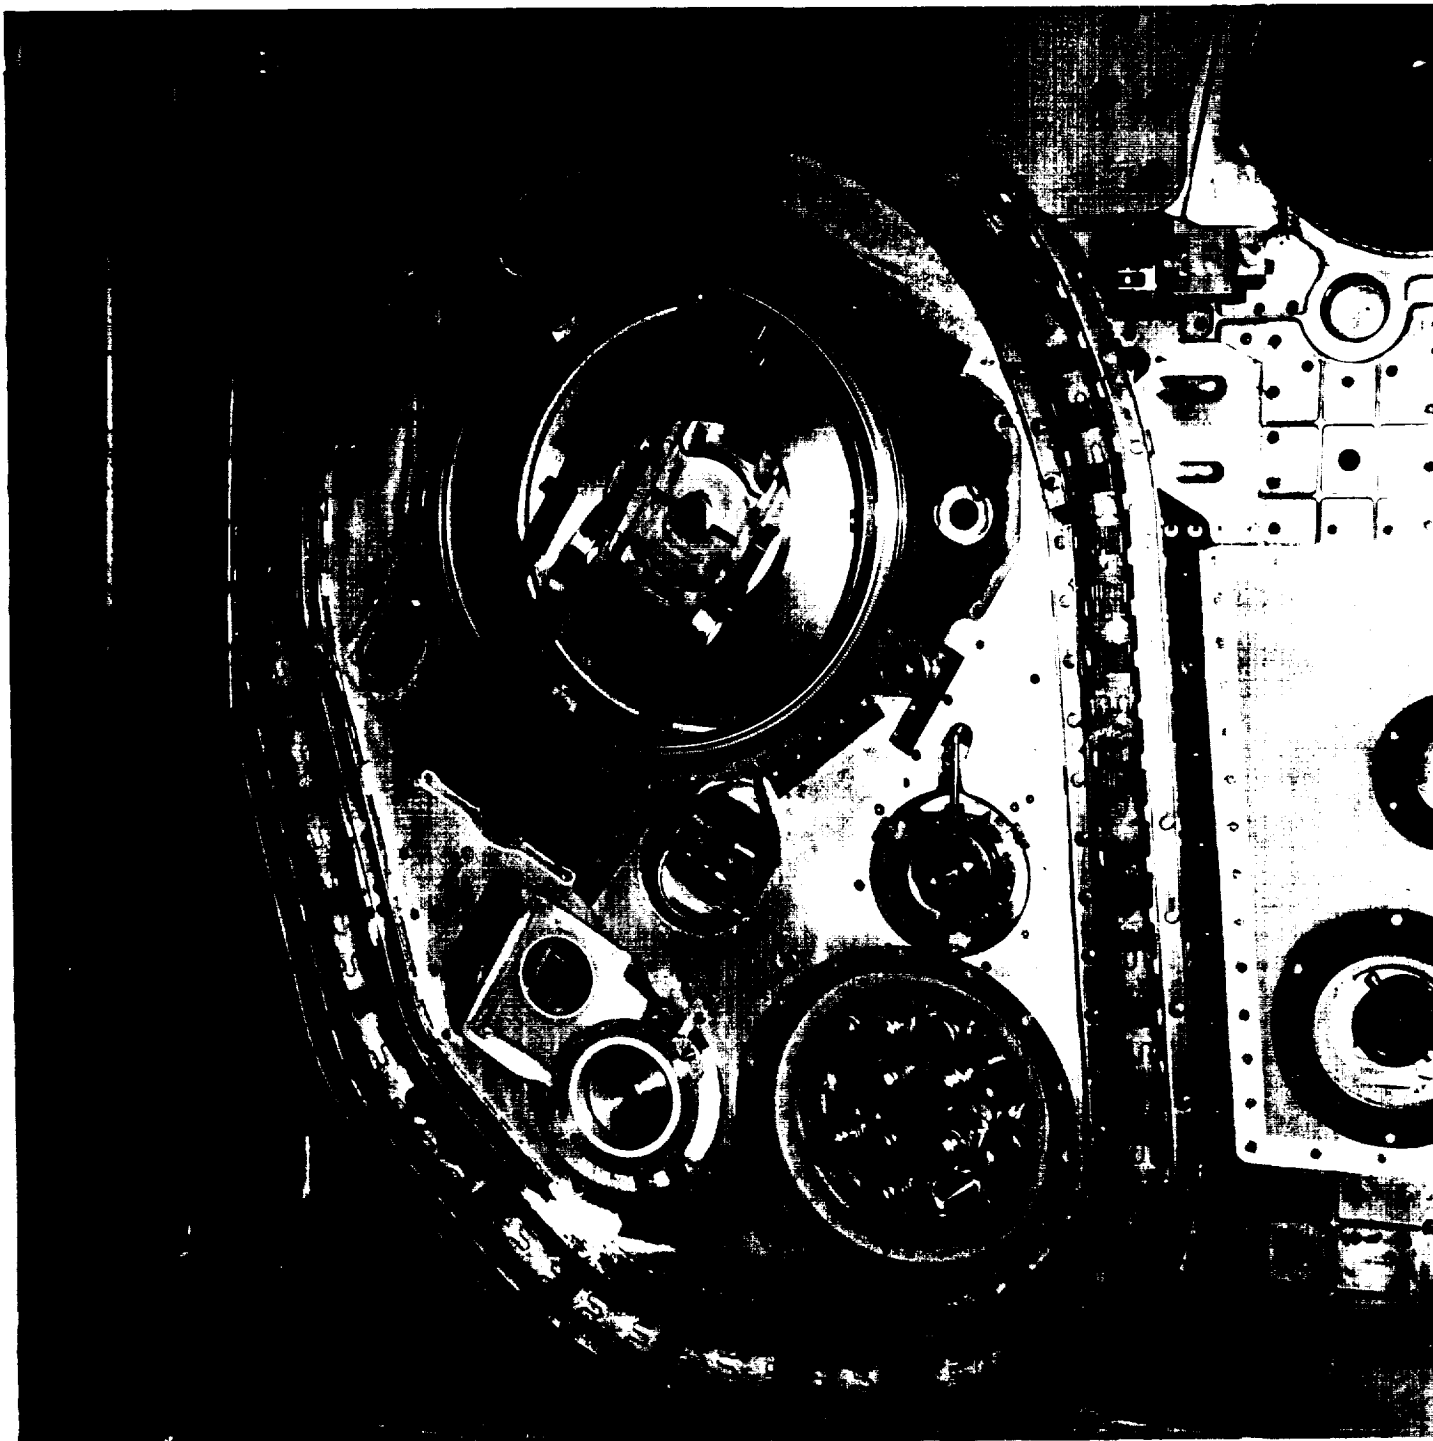
Photo 36 : LH2 ET/Orbiter Umbilical

Note closeout foam intrusion near LH2 recirculation line disconnect

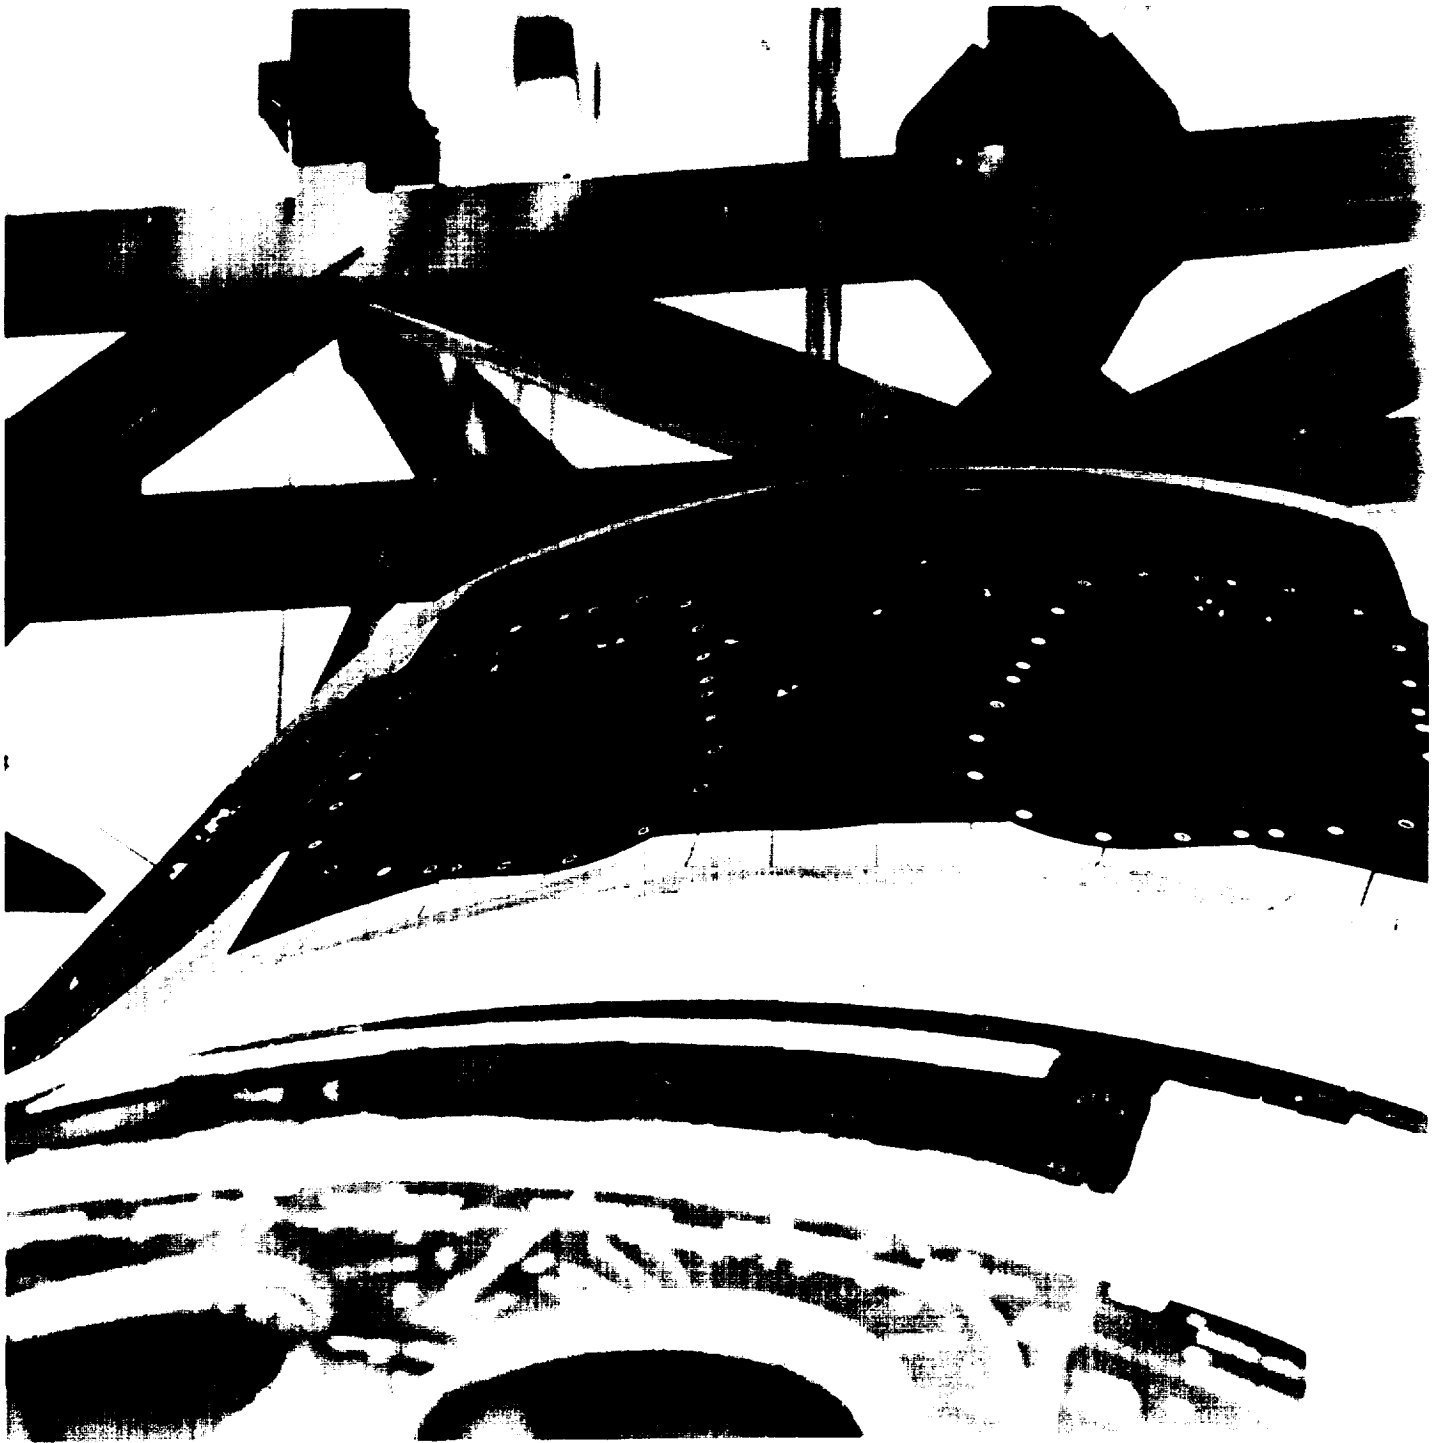
Photo 37 : Window Streaks and Perimeter Tile Damage

Orbiter windows #2, 3, 4, and #5 exhibited light hazing and streaks with windows #3 and #4 showing the most streaks. Numerous small impact sites occurred on window #2, 3, 4, and 5 perimeter tiles. Seven tile damage sites with two larger than 1-inch were present between and above windows #3 and 4. Tile hits in this area and window streaks have been attributed in the past to impacts from FRCS paper covers and/or cover RTV adhesive.

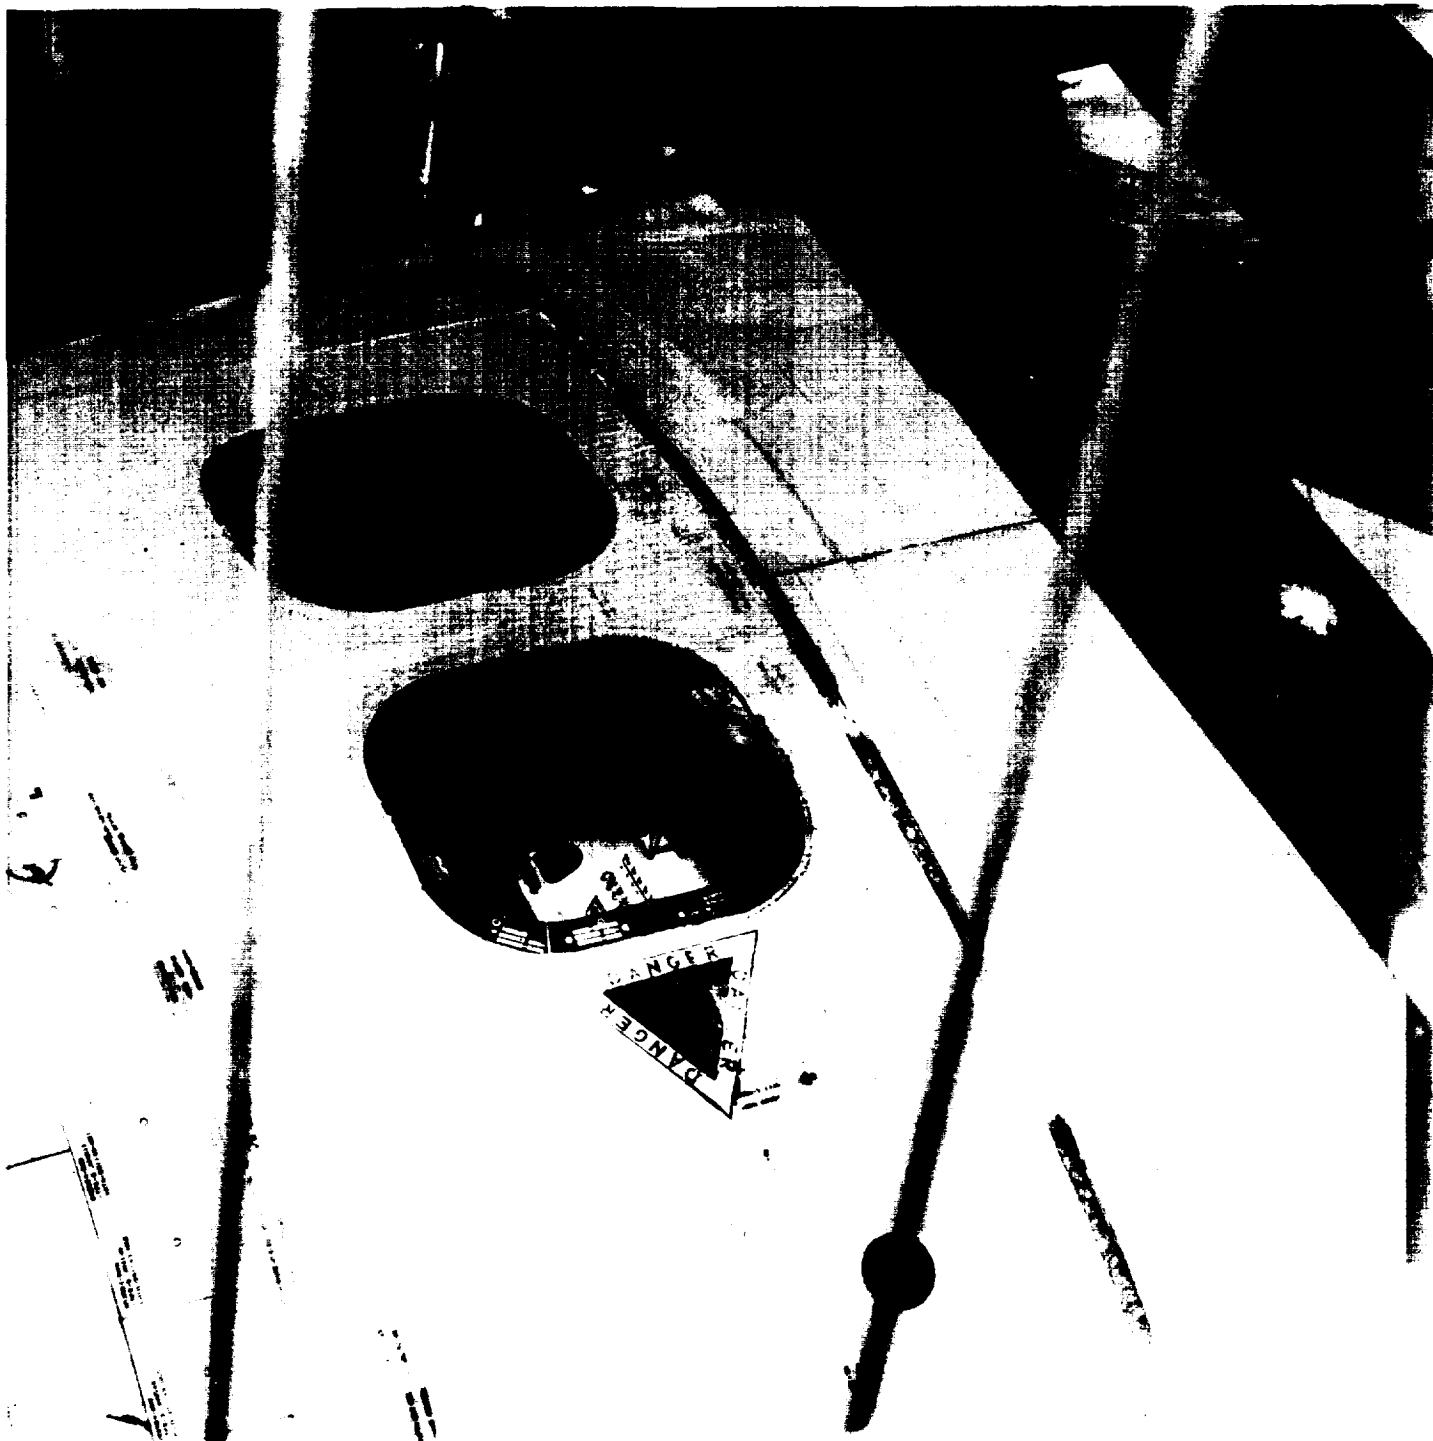
Photo 38 : Missing Perimeter Tile from Window #8
